TRANSMITTAL OF THE TOP 20 ENVIRONMENTAL RESTORATION FACT SHEETS -
TGH-339-95

Enclosed are the fact sheets developed for the top 20 Environmental Restoration (ER) sites identified during the ER Prioritization effort. Also enclosed is a cover letter to transmit these fact sheets to the Environmental Protection Agency and the Colorado Department of Public Health and Environment. These fact sheets were designed to be a quick reference for each of the top 20 sites' environmental risk, probable remediation method, and any problems which may be associated with remediation.

FACT SHEET FOR TOP 20 ENVIRONMENTAL SITES
IHSS 121, 126.1, 126.2, TANK T-8

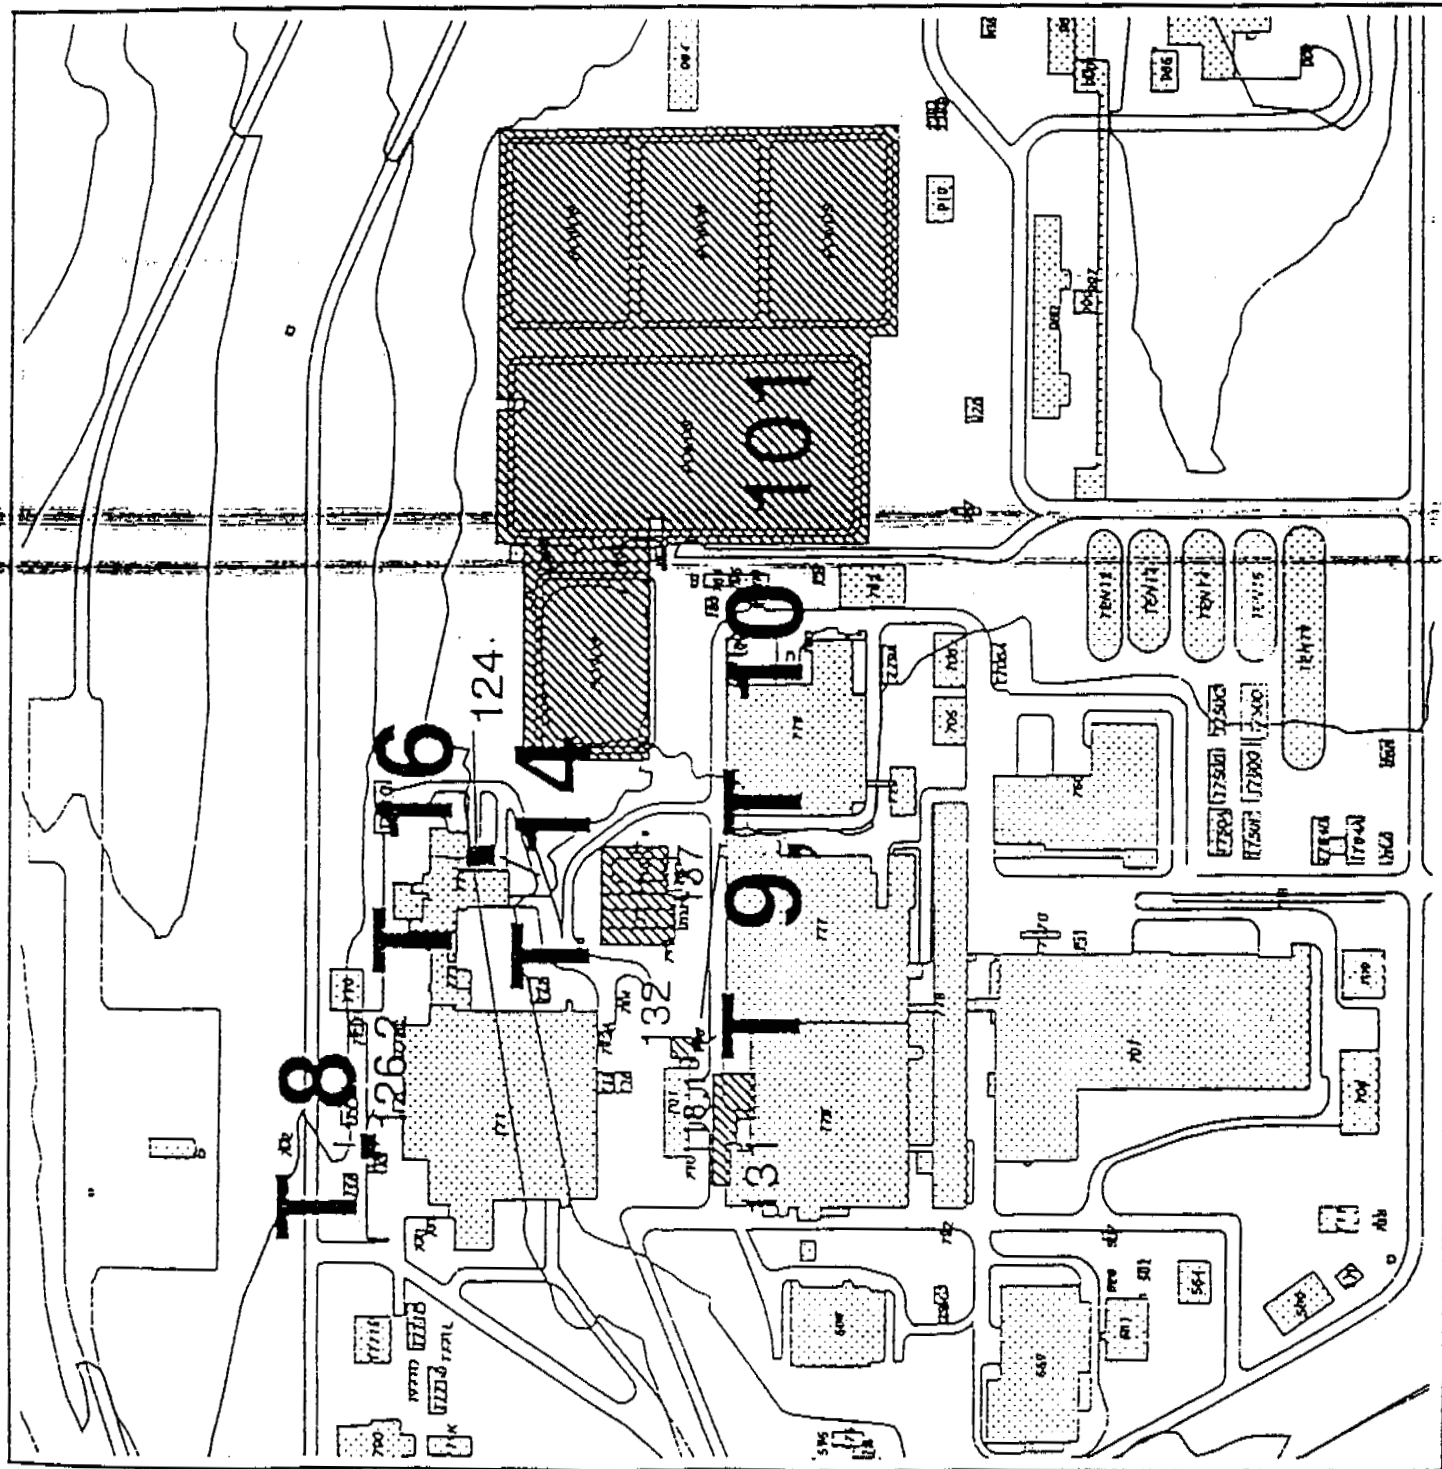
ER IHSS Ranking

- 1 - 121/124 Tank T-14
- 2 - 118.1, 132 and 121 Tanks 9&10
- 3 - 121/124.1/124.2/125 PW Tank T-16H
- 13- 131 Rad Site 11
- 15- 137 Bldg 712/713
- Cooling T Blowdown
- 17- 101 Solar Ponds
- 19- 121, 126.1, 126.2, Tank T-8
